WATER TANK INSPECTION REPORT

Town, City, Agency: Snake River Water District Date: 10/23/2020

Tank#: _____ Tank Capacity: 750K Dia.: 50 High: 32

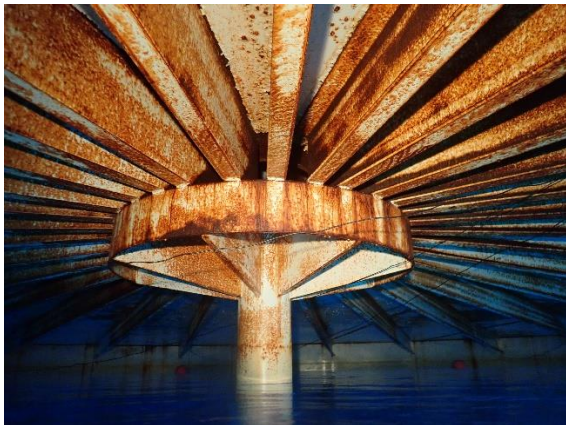
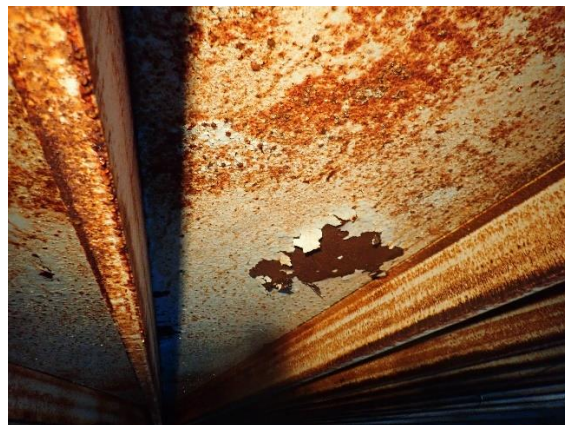
Counted thirty, 12" rafters, no replacement is necessary
